GROUP	MODEL
Safety Recall Campaign	2020MY Niro EV (DE EV)
NUMBER	DATE
SC258	March 2023

SUBJECT: **EPCU LEAK INSPECTION & REPLACEMENT (SC258)**

This bulletin provides information to inspect and, if necessary, replace the Electric Power Control Unit (EPCU) assembly on certain 2020MY Niro EV (DE EV) vehicles produced from June 18, 2020 through September 4, 2020. The EPCU assembly in the subject vehicles may have been produced with improper sealing. Due to this improper sealing, coolant can internally leak in the EPCU and contact the EPCU circuit board. If coolant contacts the EPCU circuit board, the vehicle may stall while driving. A vehicle stall increases the risk of crash. Follow the procedure outlined in this publication to inspect the EPCU for an internal coolant leak and, if needed, replace the EPCU assembly. Before conducting the procedure, verify that the vehicle is included in the list of affected VINs.

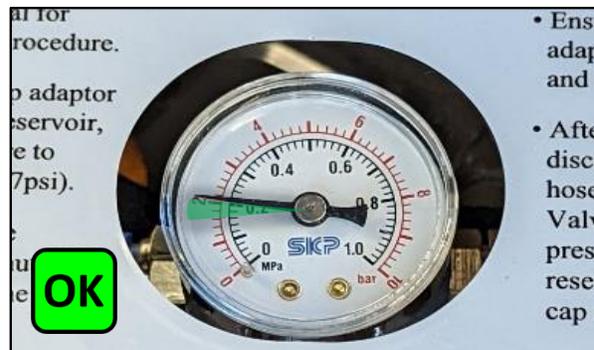
- If the air pressure reading remains between 1.8-2.0 bar (26-29 psi) for 30 minutes, then EPCU is **(OK)**. Reinstall all removed parts in the reverse order of removal, refill coolant and follow the 'Refill/Bleeding Procedure' outlined in KGIS.

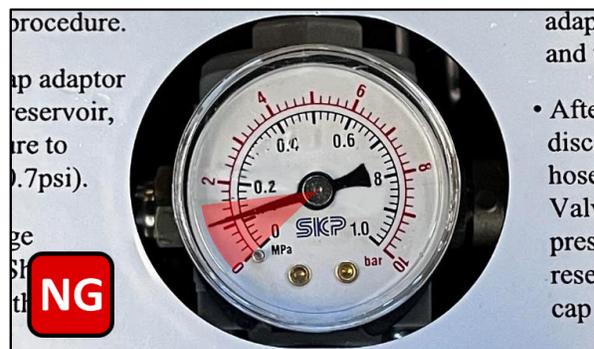
- If air pressure falls below 1.8 bar (26 psi) within 30 minutes, then the EPCU is **(NG)** and has an internal leak. Proceed to the 'Repair Procedure' on page 7 to replace the EPCU.

1. Replace the EPCU by referring to the "Vehicle Control System → Electronic Power Control Unit (EPCU) → Repair procedures" chapter in the applicable Shop Manual on KGIS.
