GROUP	MODEL
Safety Recall Campaign	2020MY Niro EV (DE EV)
NUMBER	DATE
SC258	March 2023

SUBJECT: **EPCU LEAK INSPECTION & REPLACEMENT (SC258)**

This bulletin provides information to inspect and, if necessary, replace the Electric Power Control Unit (EPCU) assembly on certain 2020MY Niro EV (DE EV) vehicles produced from June 18, 2020 through September 4, 2020. The EPCU assembly in the subject vehicles may have been produced with improper sealing. Due to this improper sealing, coolant can internally leak in the EPCU and contact the EPCU circuit board. If coolant contacts the EPCU circuit board, the vehicle may stall while driving. A vehicle stall increases the risk of crash. Follow the procedure outlined in this publication to inspect the EPCU for an internal coolant leak and, if needed, replace the EPCU assembly. Before conducting the procedure, verify that the vehicle is included in the list of affected VINs.

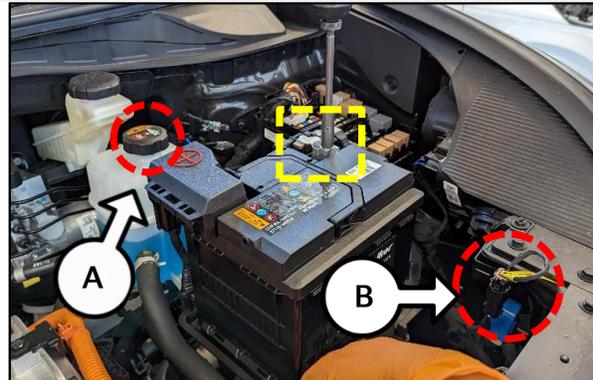
1. Remove coolant reservoir cap (A).
2. Disconnect negative (-) battery terminal.
3. Shut off the high voltage circuit by referring to the "Hybrid Control System → High Voltage Shut-off Procedures" and remove the Service Interlock connector (B).

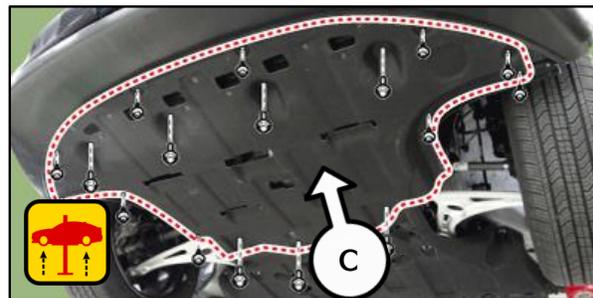
4. Raise the vehicle on a lift and remove the undercover (C).

Tightening torque for undercover bolts:  
2.9 - 4.3 lb.ft (3.9 - 5.9 N.m)

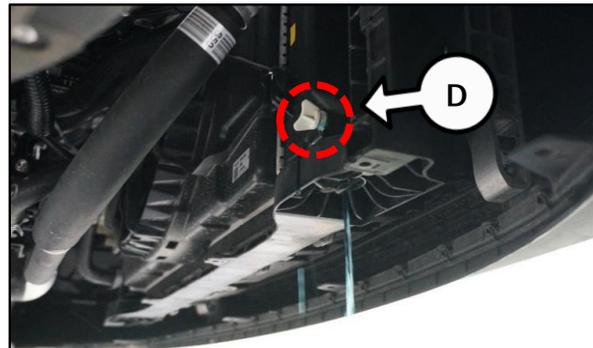
5. Drain coolant onto a drain pan by loosening coolant drain plug (D).

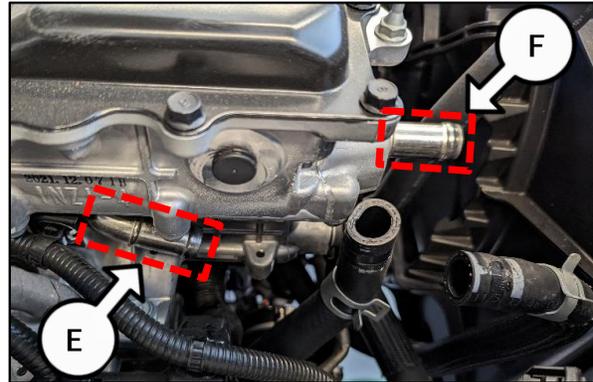
- 7a. Disconnect the EPCU coolant hose from the EPCU discharge outlet (E).
- 7b. Disconnect the coolant hose from the on-board charger (OBC) outlet (F).

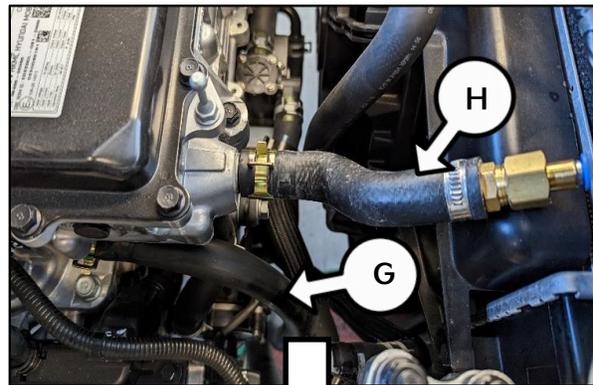
8. Connect the SST coolant 'discharge hose' (G) to the EPCU outlet (E).

9. Connect the SST 'pressure hose' (H) to the OBC outlet (F).

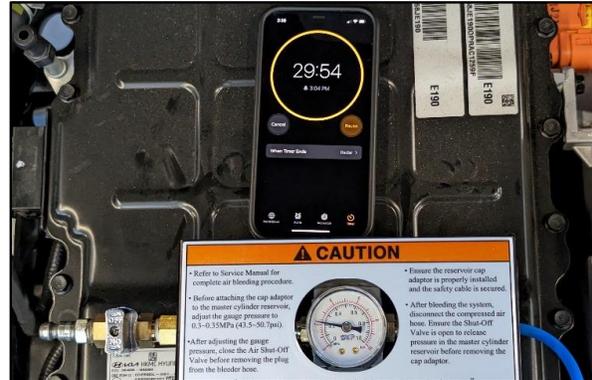
18. Disconnect the shop air supply hose from the SST air bleeding device.

Begin monitoring the air pressure reading on the SST gauge for up to thirty (30) minutes.

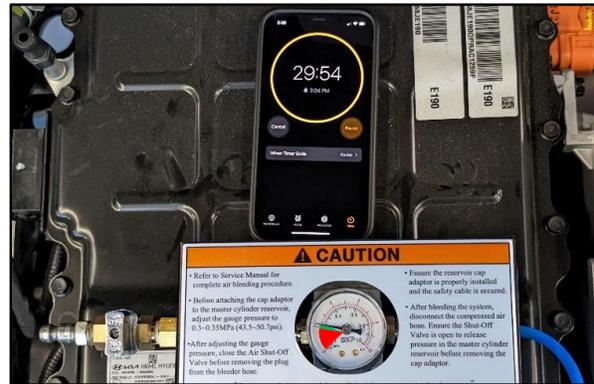
- While monitoring the air pressure reading on the SST gauge for thirty (30) minutes, the 2 bar (29 psi) air pressure reading on the gauge should not decrease:

- If the air pressure reading remains between 1.8-2.0 bar (26-29 psi) for 30 minutes, then EPCU is **(OK)**. Reinstall all removed parts in the reverse order of removal, refill coolant and follow the 'Refill/Bleeding Procedure' outlined in KGIS.

- If air pressure falls below 1.8 bar (26 psi) within 30 minutes, then the EPCU is **(NG)** and has an internal leak. Proceed to the 'Repair Procedure' on page 7 to replace the EPCU.
